## **Limited Visual Dam Safety Inspection Summary Report**

**MA-046**

**Waikamoi Dam Number 2**

**May 2006**

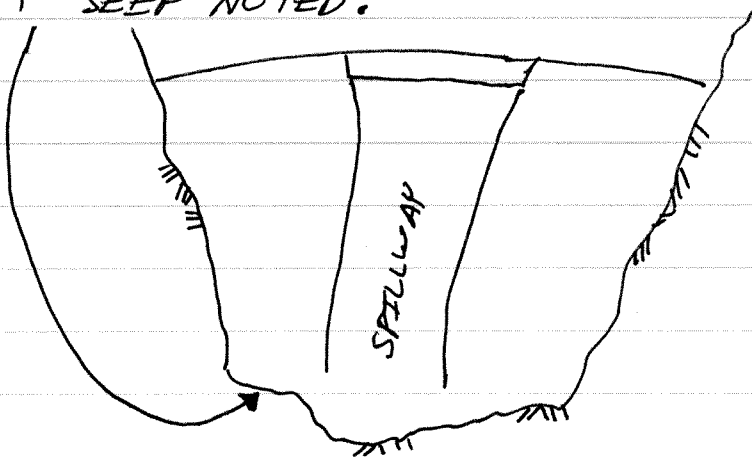
2) THE ARCH DAM WAS BUILT PRIOR TO THE ROUTINE CONSIDERATION OF UPLIFT SEEPAGE FORCES. DAM STABILITY SHOULD BE EVALUATED BASED ON CURRENT CRITERIA.

3) SLIGHT SEEP NOTED.
